MATERIALS TECHNOLOGY FOR COAL-CONVERSION PROCESSES

**Thirteenth Quarterly Report,
January—March 1978**

ANL-78-54

Task F -- Component Performance and Failure Analysis (S. Danyluk, G.M. Dragel, W.J. Shack, and J.Y. Park)

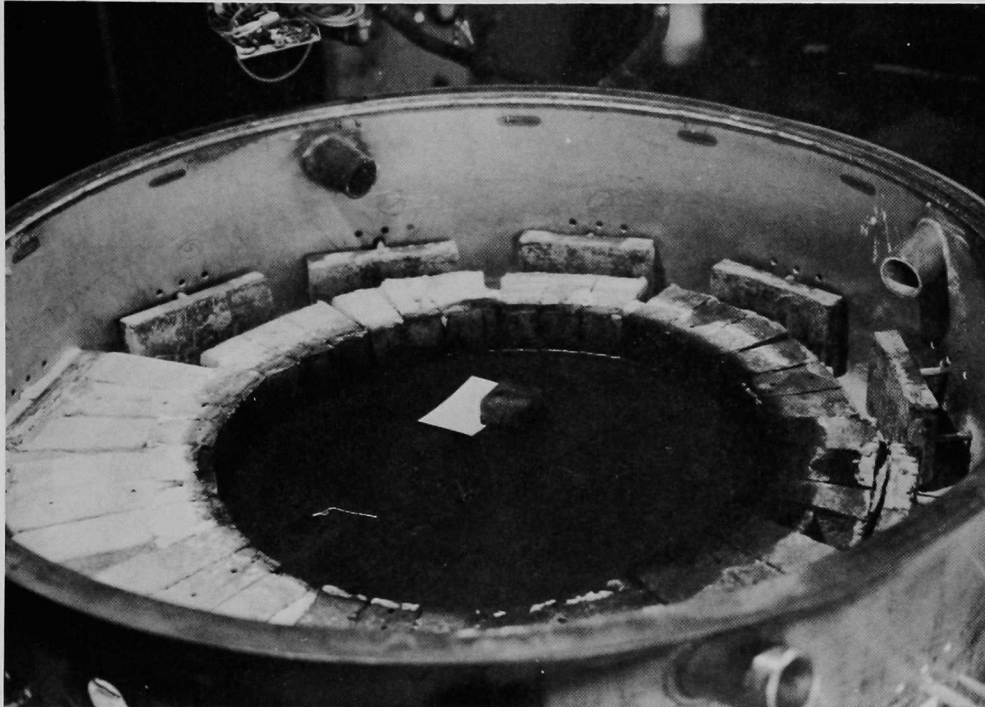
Fig. 4. Posttest Photograph Showing the Placement of the Standard Specimen of Refractory Number 2. Note that the furnace has been partially disassembled, the insulating upper wall has been removed, and the cooling cans for the 1/2-size bricks have been detached. A 76-mm x 127-mm (3-in. x 5-in.) file card has been placed next to the specimen to illustrate the depth of corrosion.

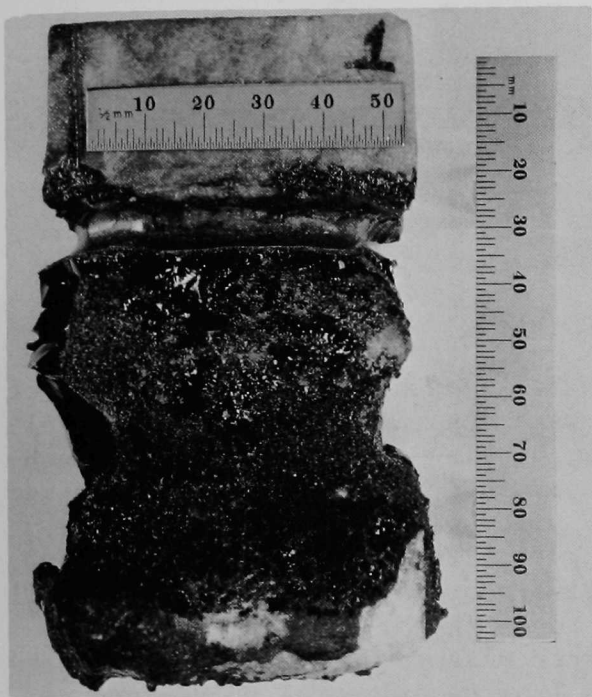
Fig. 10. Posttest Photograph of the Standard Specimen of Refractory Number 2 That Was Partially Immersed in the Slag Bath Without Water Cooling in Test Run 8. Note the two lines of slag attack extending around the specimen.

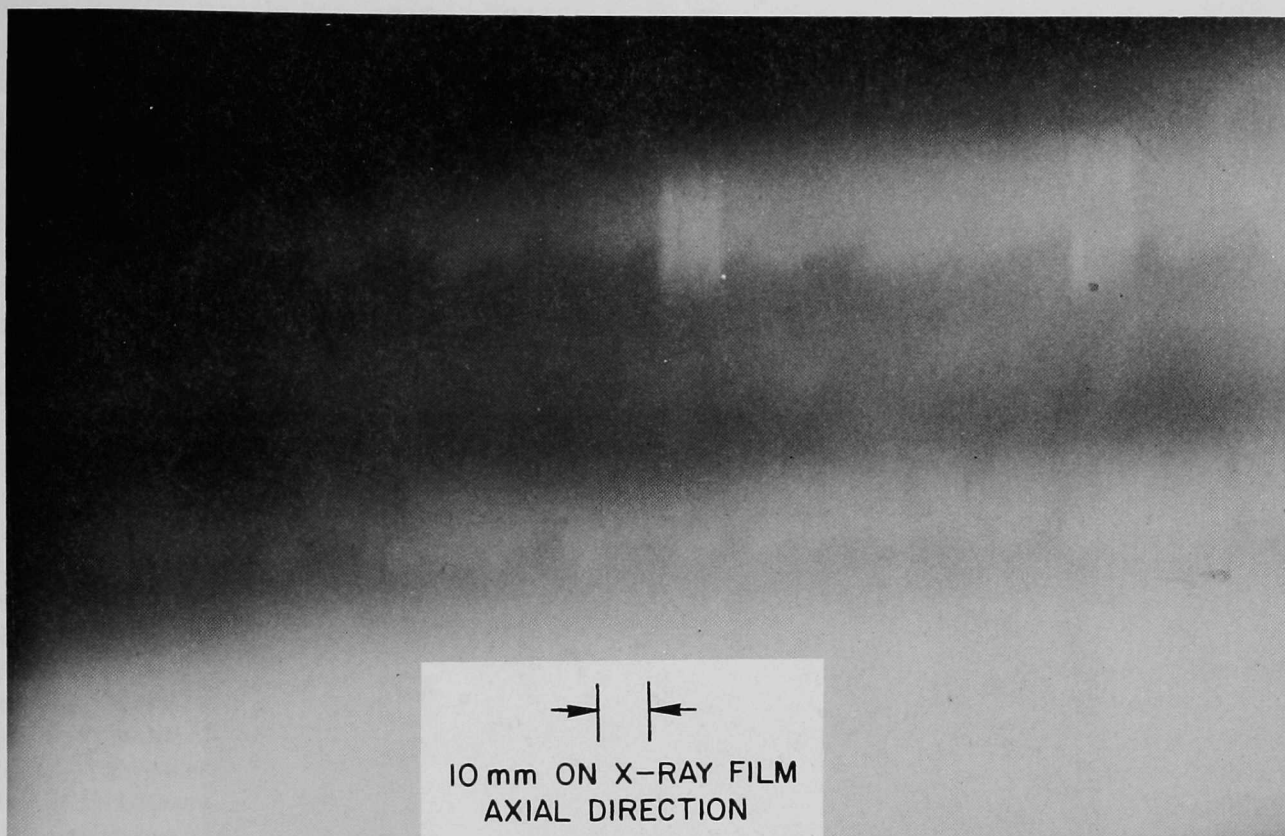
Fig. 14. Erosion Pattern of Longitudinal Sawtooth Ridges in 0.51-m-long Cone of Type 316 Stainless Steel Within Body of HYGAS Cyclone Separator. X-ray view exposed through the entire assembly. Neg. No. ANL-306-78-463

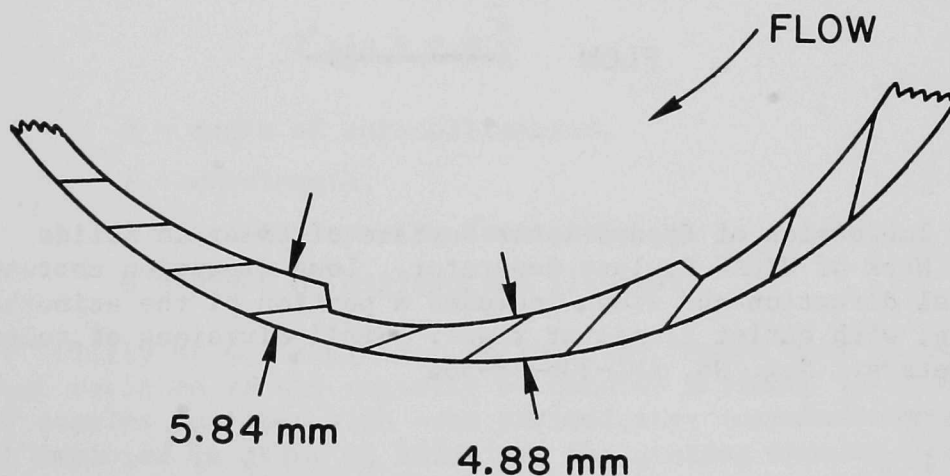
Fig. 15. Schematic of End View of Long Cone Within Body of HYGAS Cyclone Separator, Showing Sawtooth Erosion Pattern and Dimensions at Sites 0.5 m from Solids Outlet Flange. Original thickness of the cone was 6.35 mm. Neg. No. ANL-306-78-537

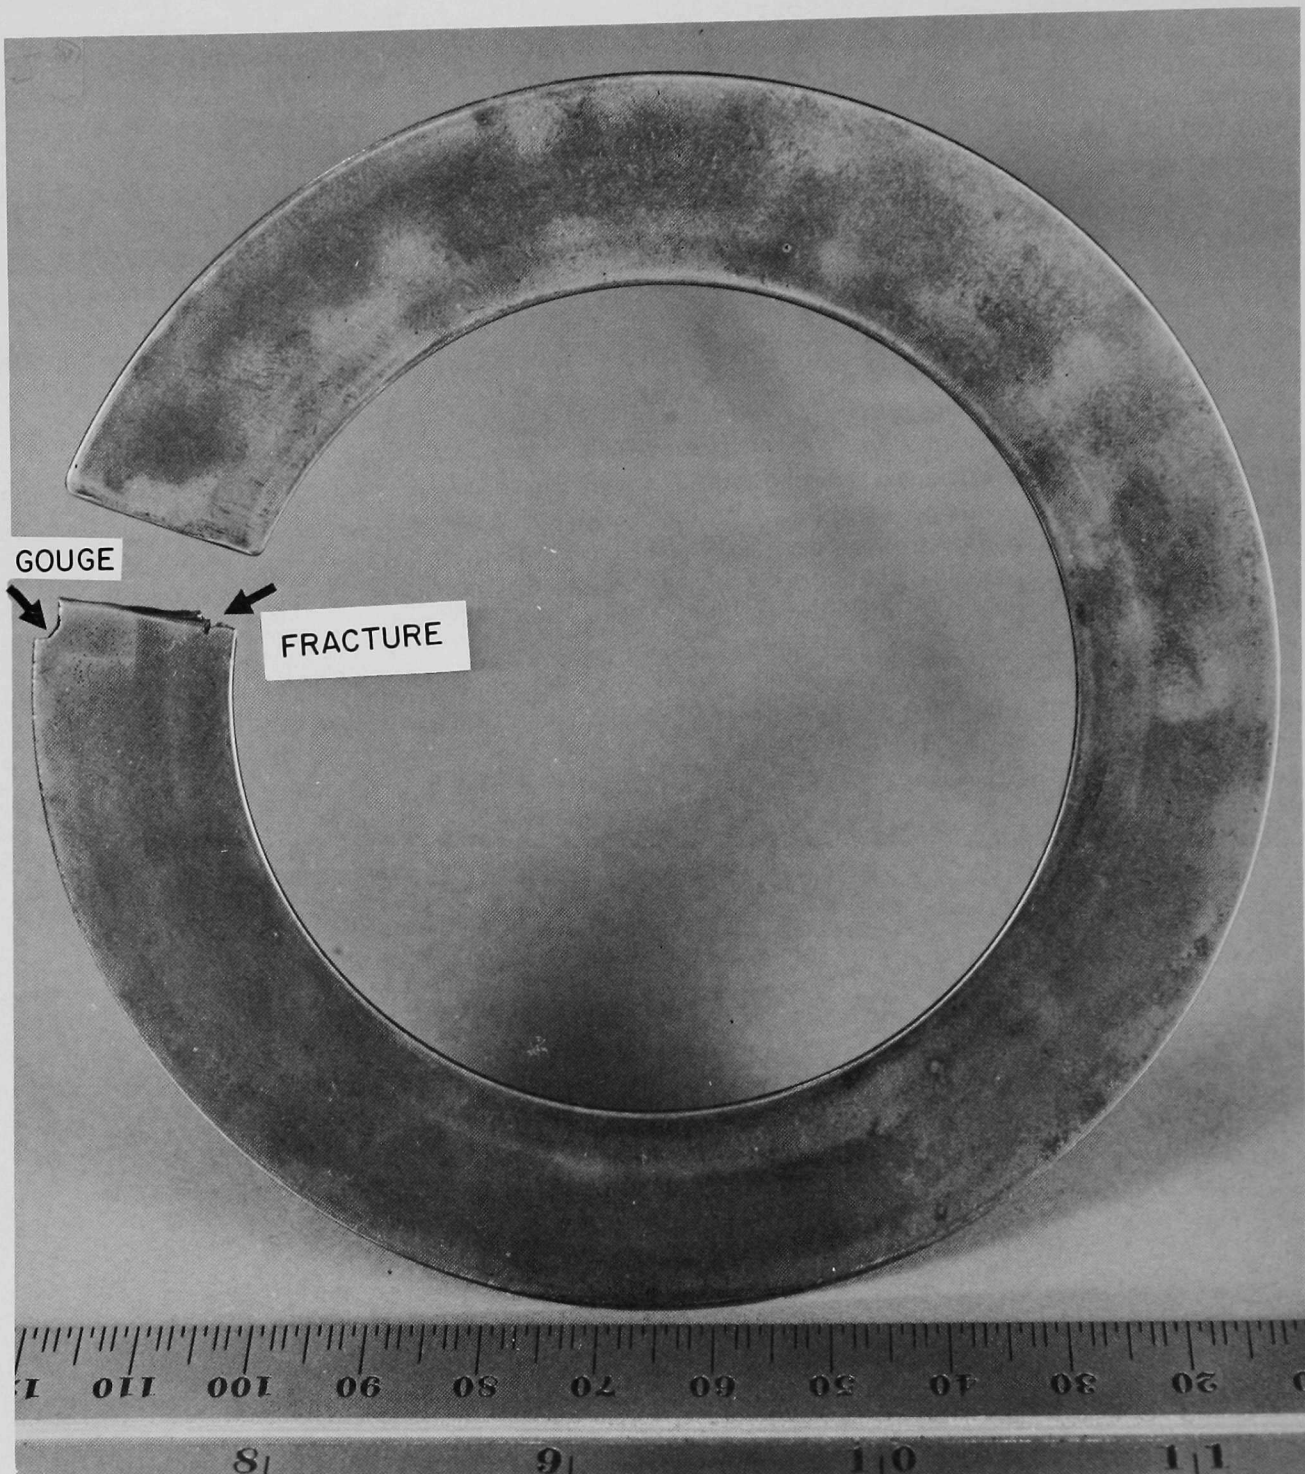
Fig. 50. HYGAS Valve Assembly Leaf Spring. The spring is helical and the fracture surface and gouge are readily visible. ANL Neg. No. 306-77-546

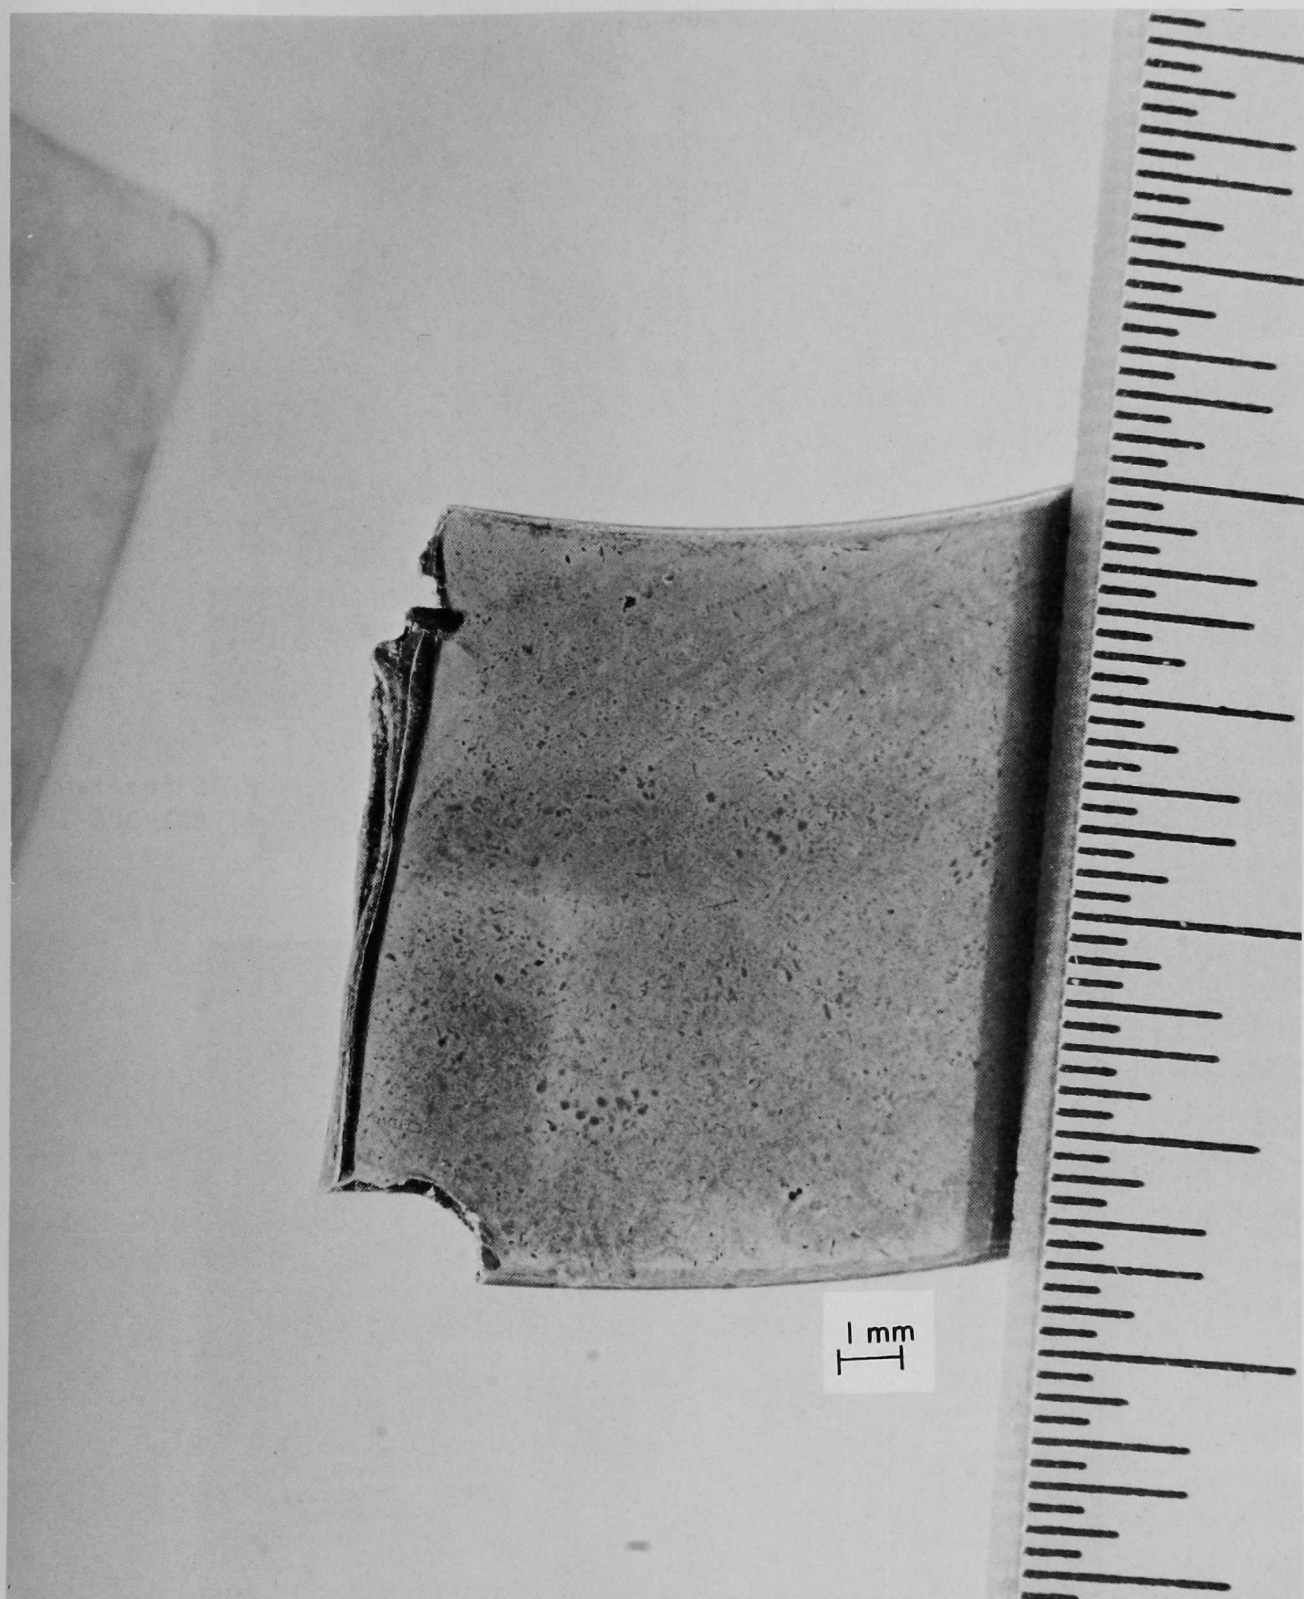
Fig. 51. Enlarged View of Fracture Surface and Gouged Area of HYGAS Valve Assembly Leaf Spring. ANL Neg. No. 306-77-547

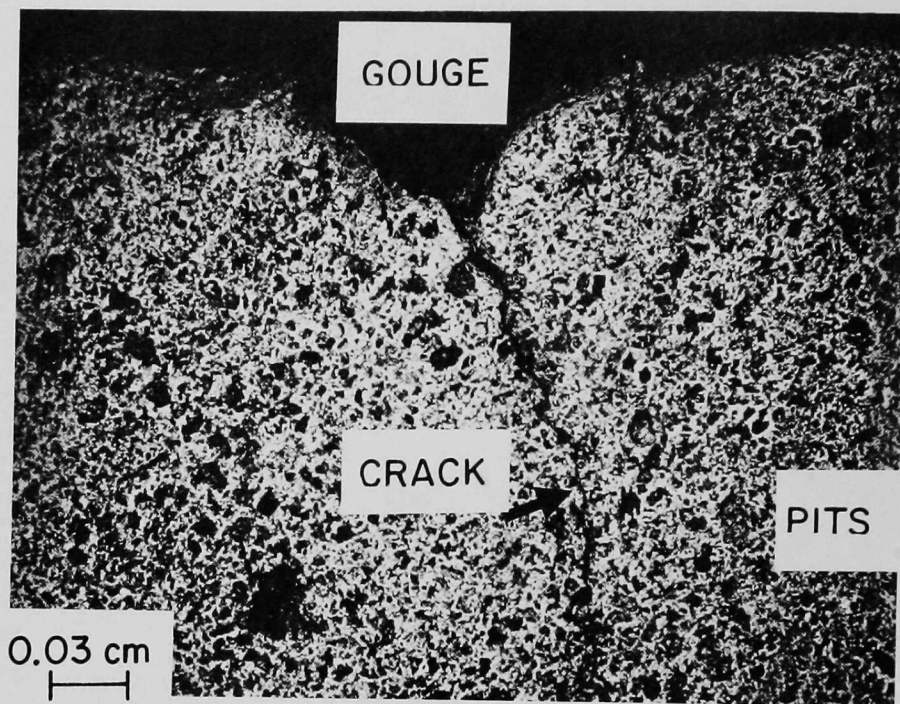
Fig. 52. Top Surface of HYGAS Valve Assembly Leaf Spring, in the As-received Condition. A crack is emanating from a gouge. Neg. No. ANL-306-78-580

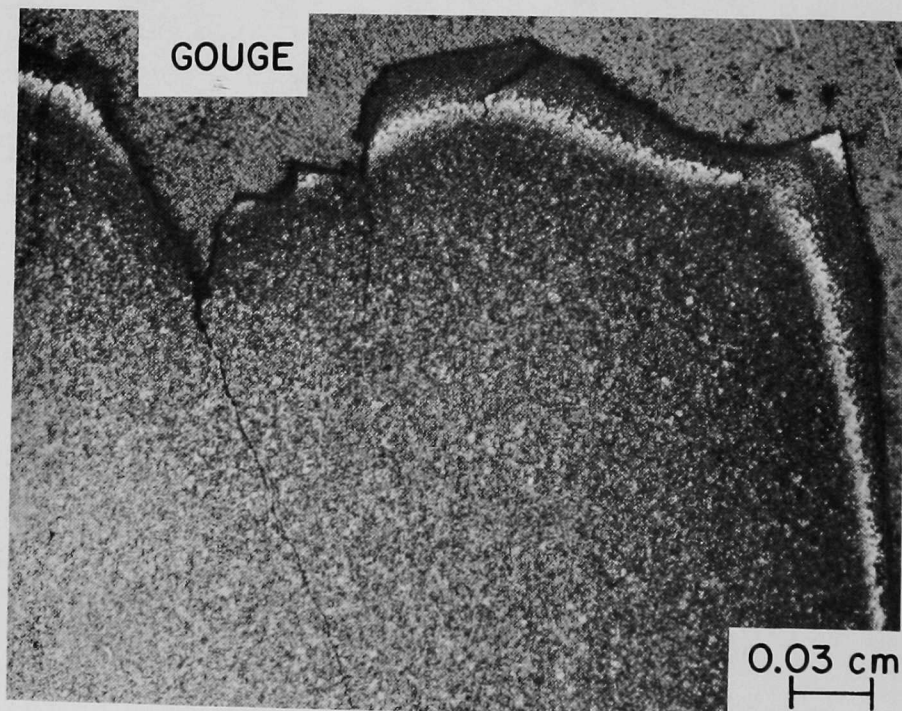
Fig. 53. Polished and Etched Surface of HYGAS Valve Assembly Leaf Spring, Showing Cracks Originating in a Gouged Region. Neg. No. ANL-306-78-574

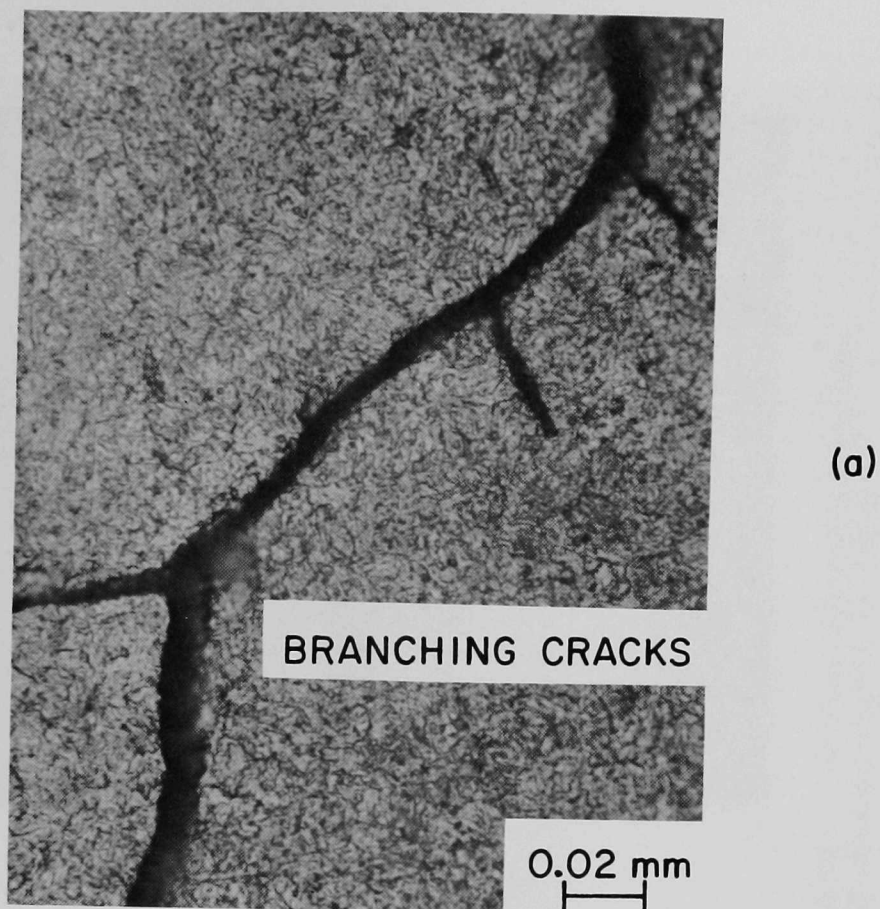
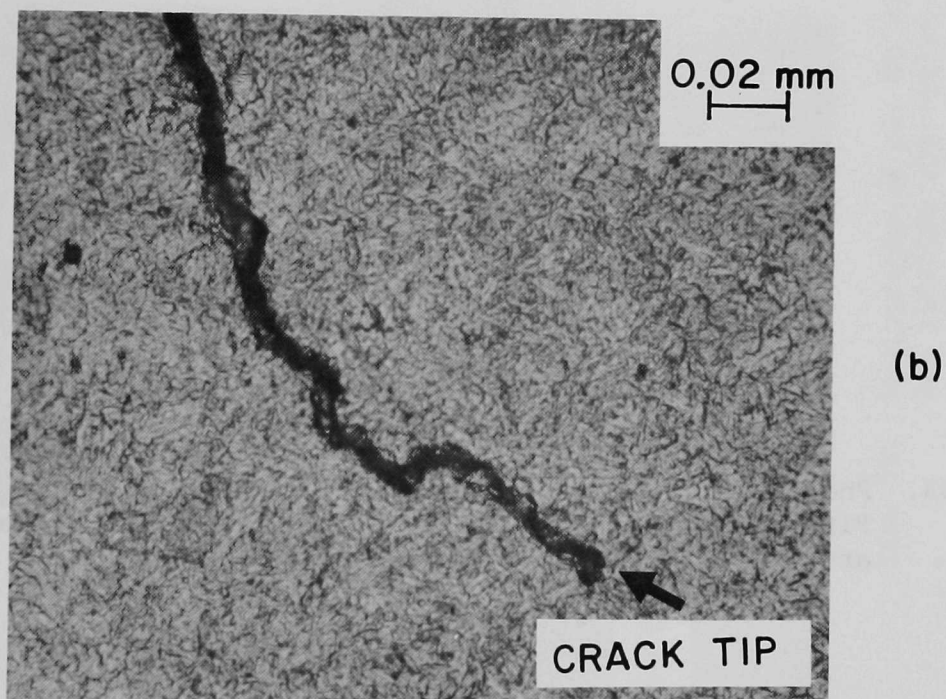
Fig. 54. HYGAS Valve Assembly Leaf Spring Cracks. Branched cracks are shown in (a) and the crack tip is shown in (b). The microstructure is tempered martensite. Neg. No. ANL-306-78-583

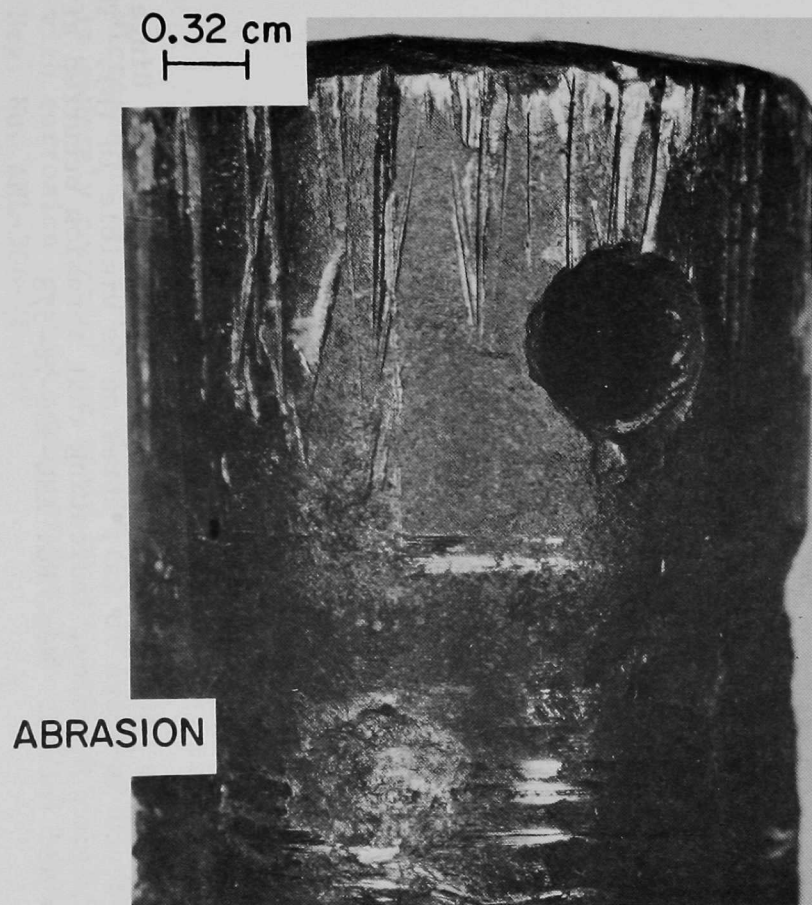
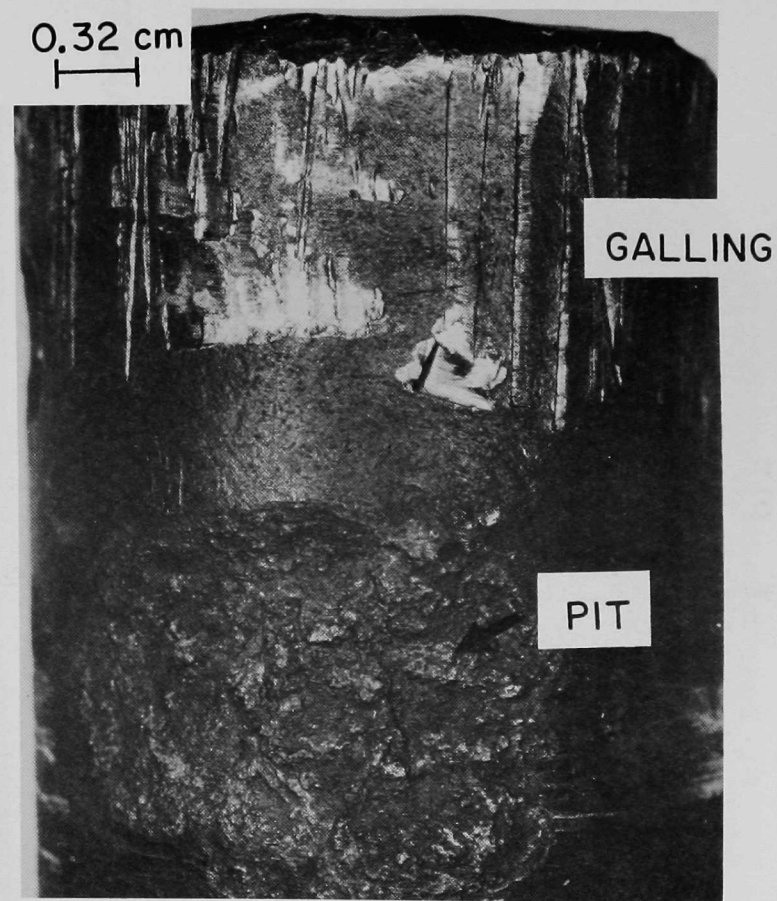
Fig. 56. Photographs of the HYGAS Hinge Pin. Pitting corrosion, galling, and abrasion are visible. The abraded region is shiny.
Neg. No. ANL-306-78-568

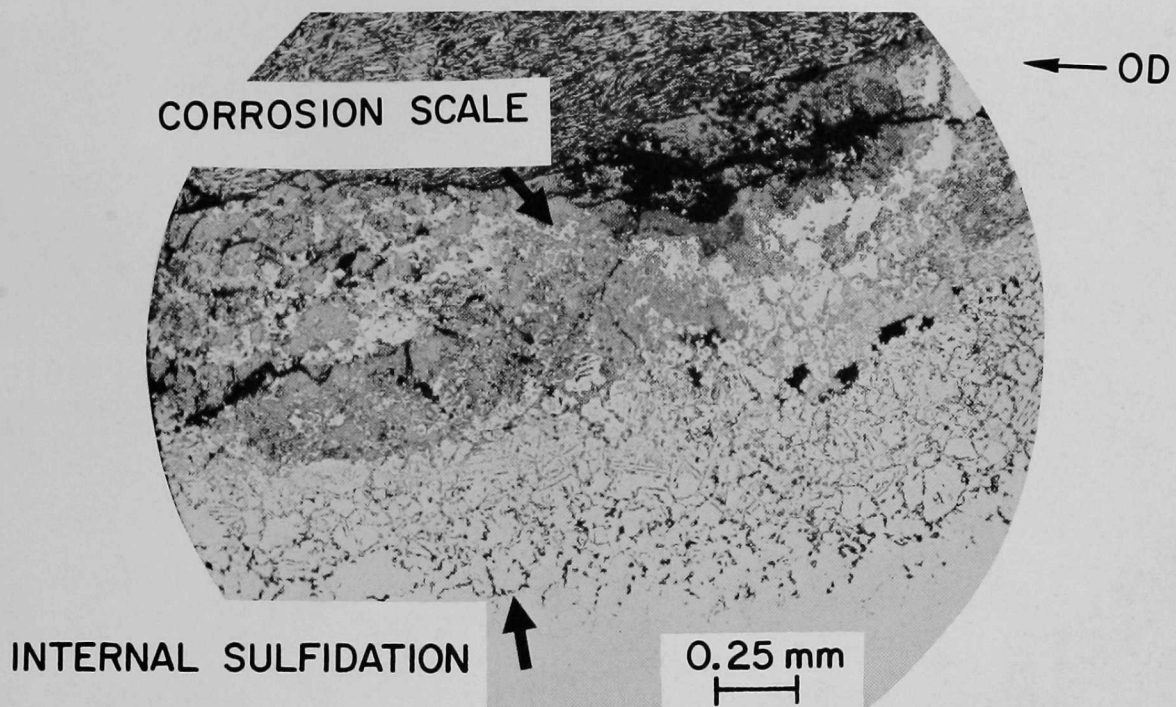
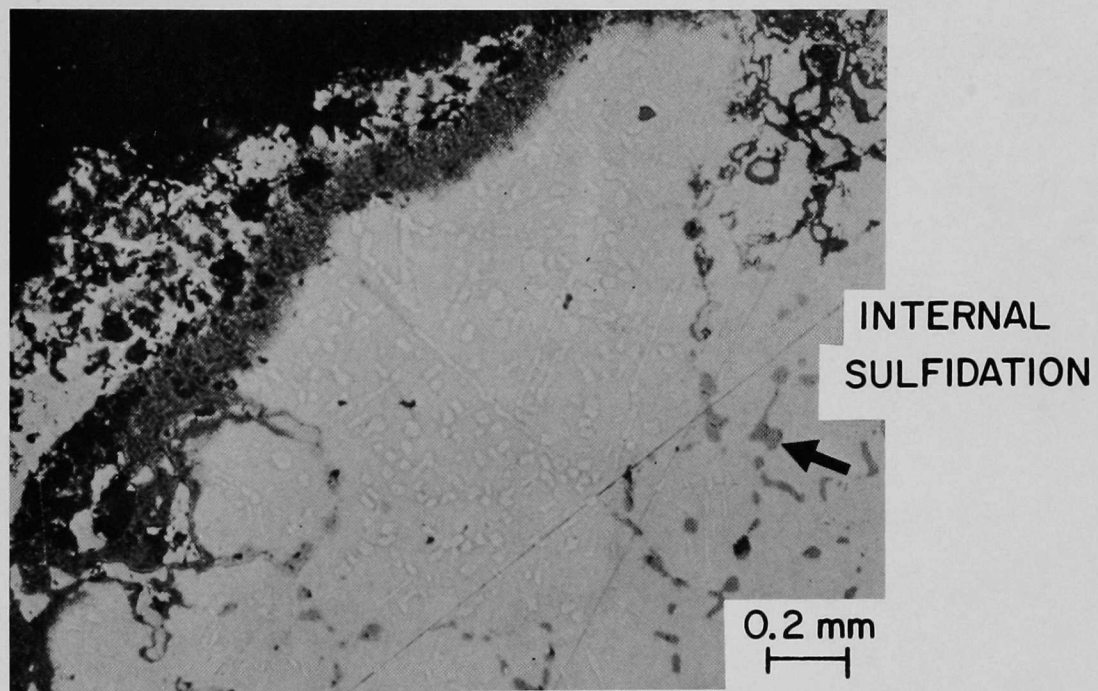
Fig. 58. Micrographs of Corroded Regions of the HYGAS Hinge Pin. The OD is severely corroded and grain boundaries and twins are outlined with corrosion product, most probably a sulfide phase.
Neg. No. ANL-306-78-569

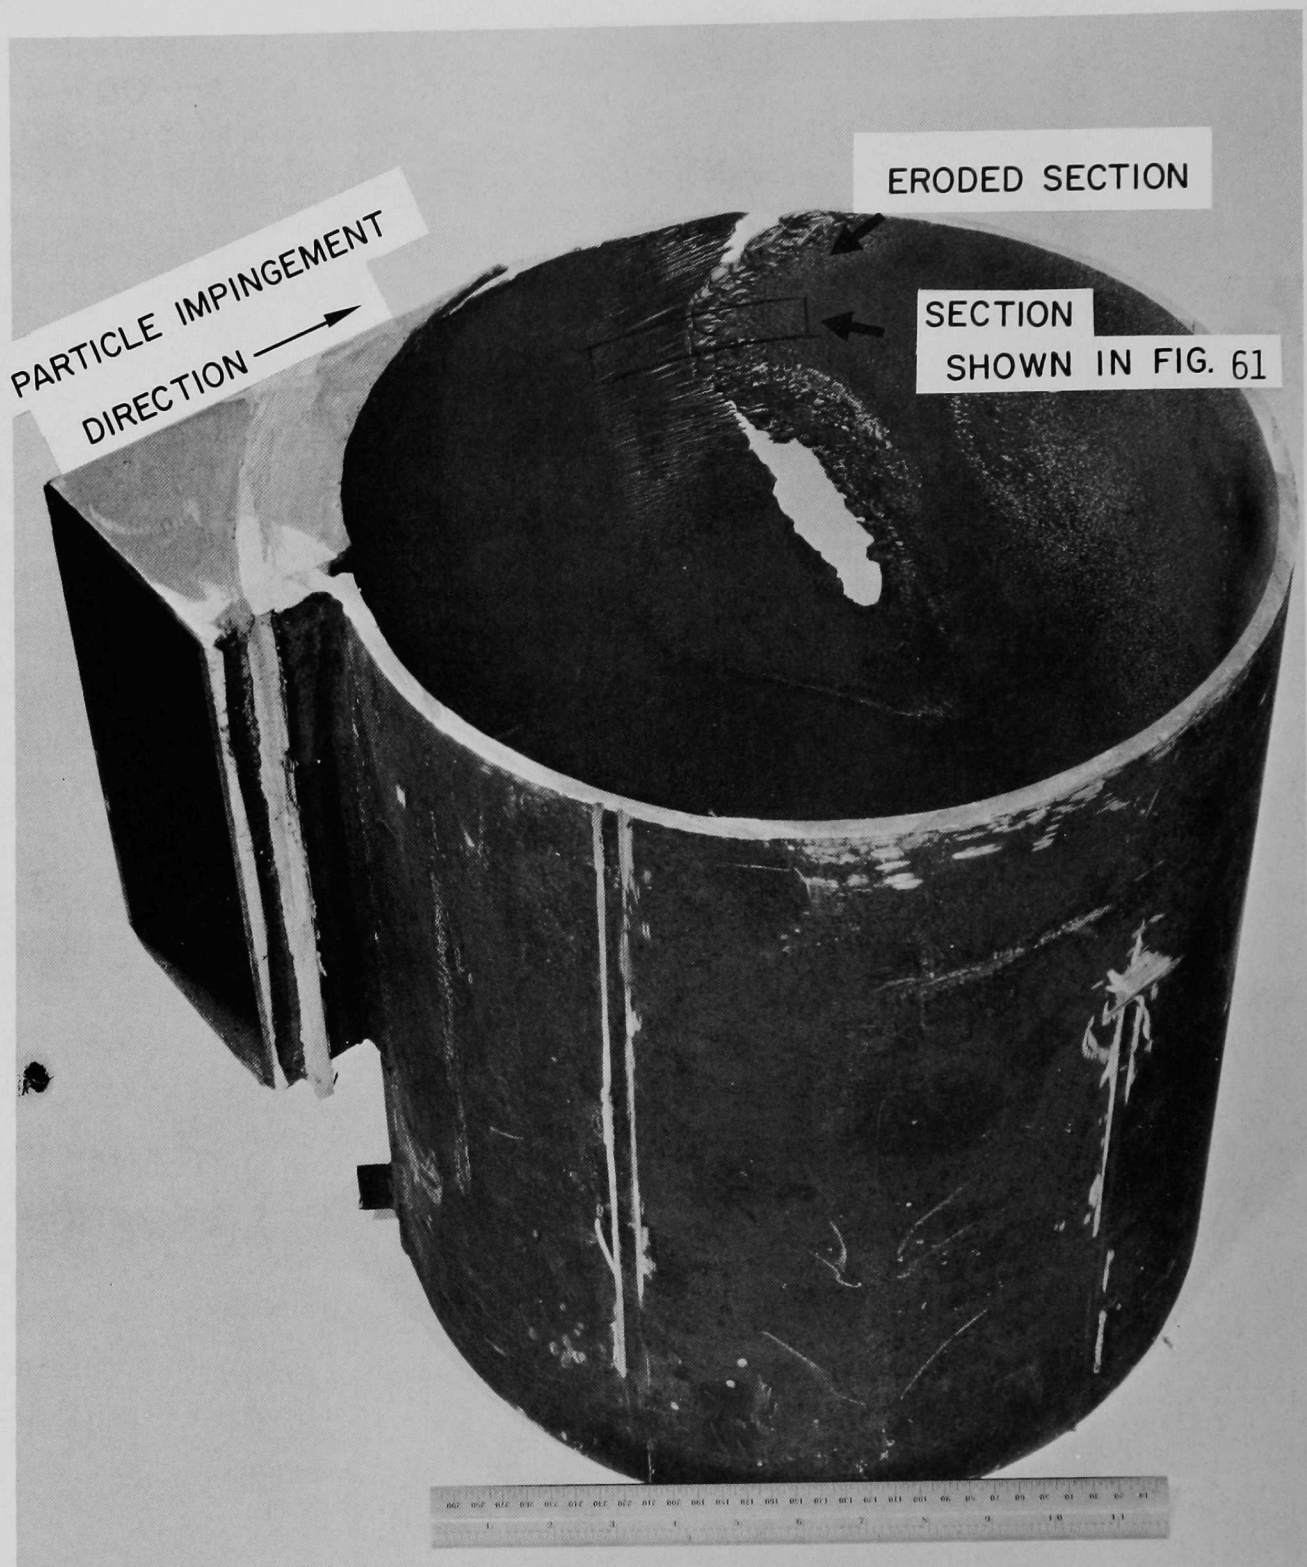
Fig. 59. Photograph of the Type 310 Stainless Steel Internal Cyclone. The particle impingement direction and the eroded section are indicated. ANL Neg. No. 306-77-543

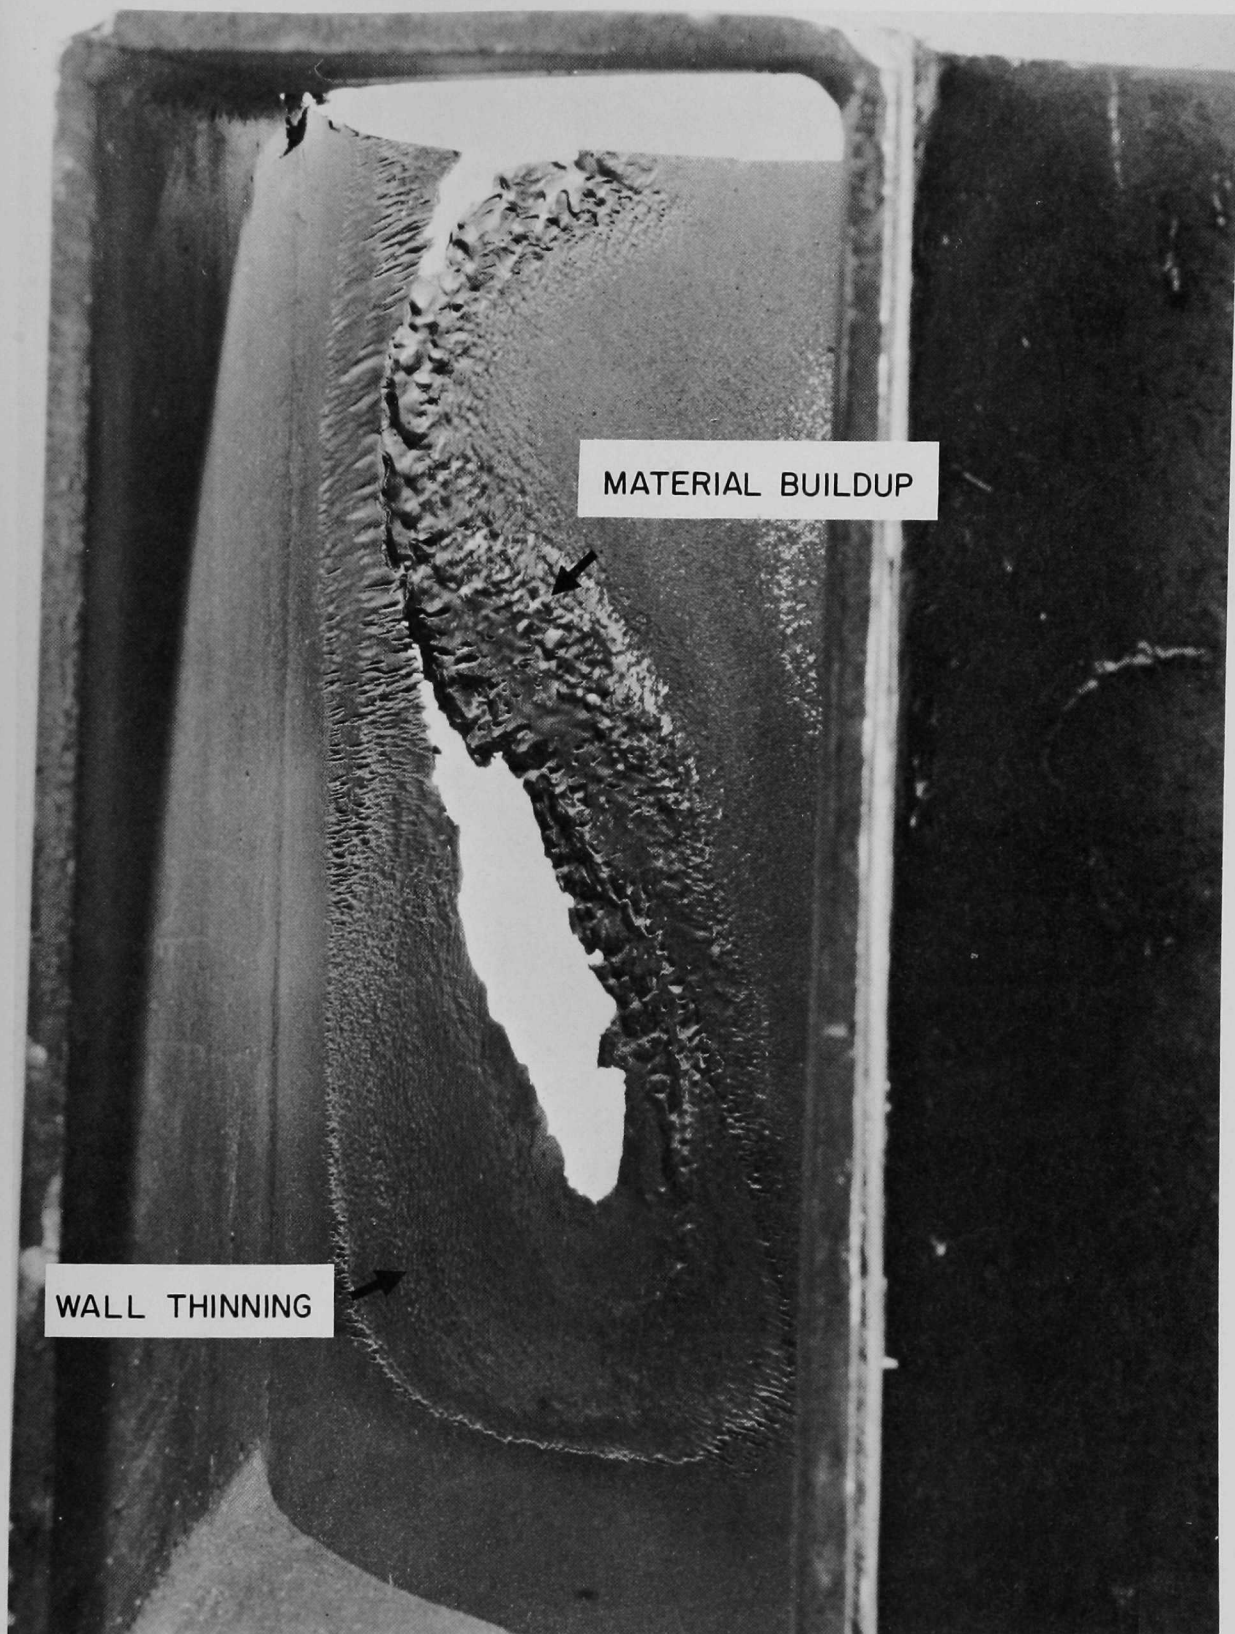
Fig. 60. Photograph of the Eroded Region of the Internal Cyclone. The view is through the particle inlet section. Wall thinning is seen at the near section and material buildup is seen at the far section of the perforation. ANL Neg. No. 306-77-541

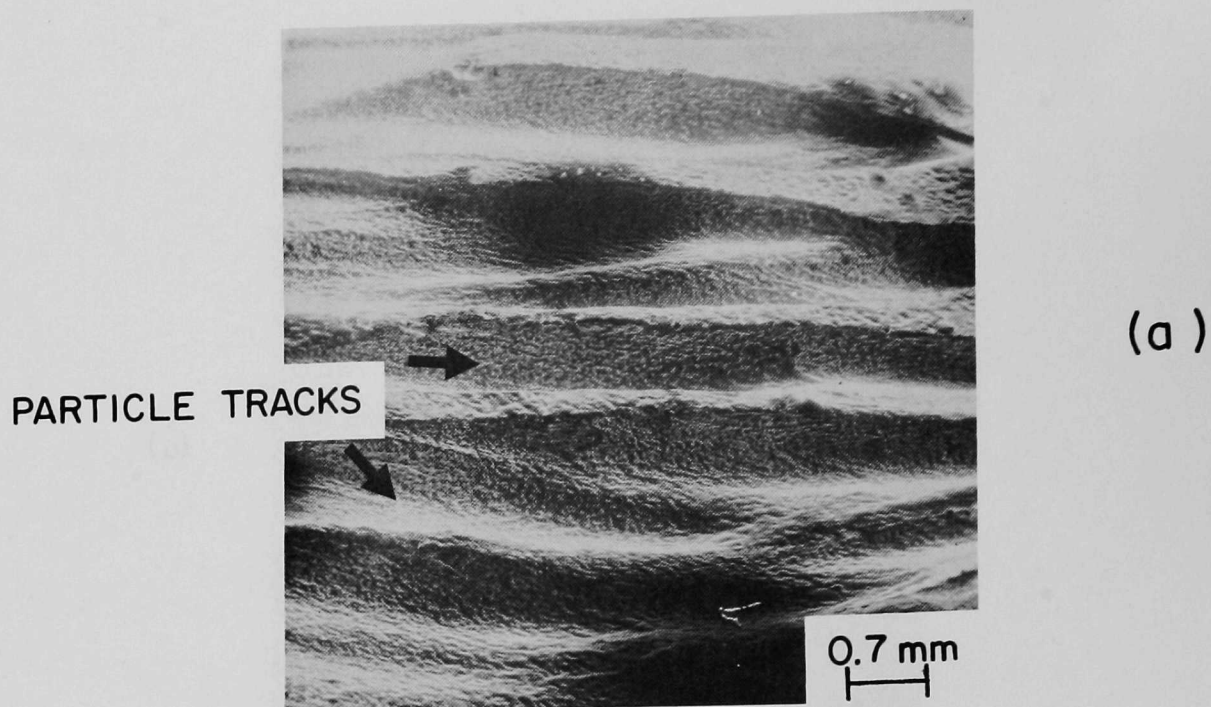
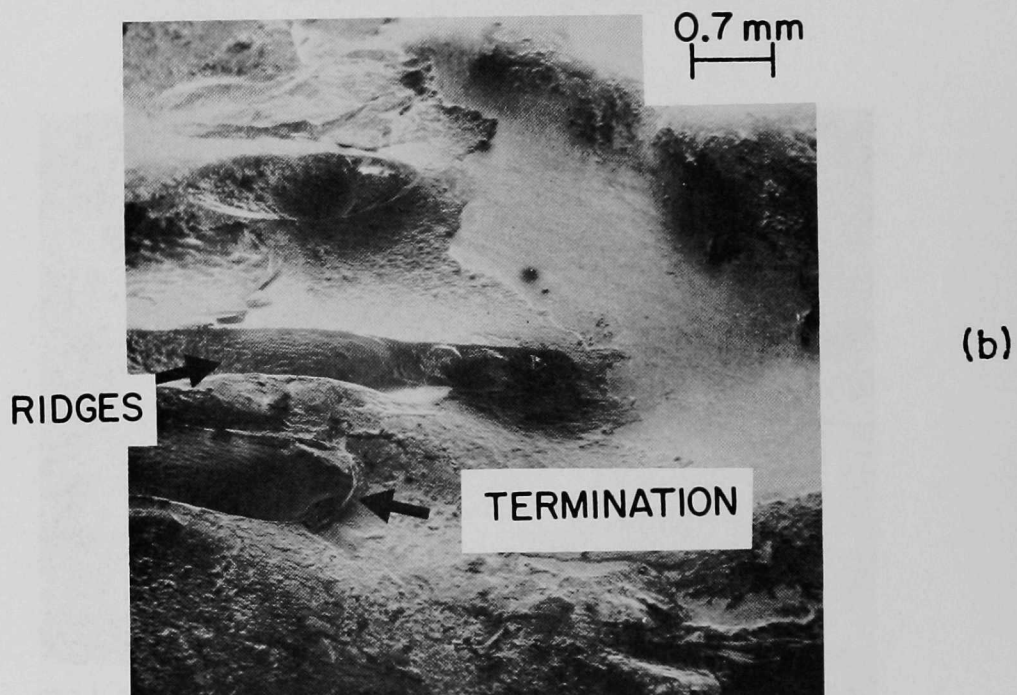
Fig. 63. Scanning-electron Micrographs of the Eroded Surface. Ridges in (a) are caused by particle deformation of the surface. The micrograph in (b) shows the termination points of particle trajectories.
Neg. No. ANL-306-78-582

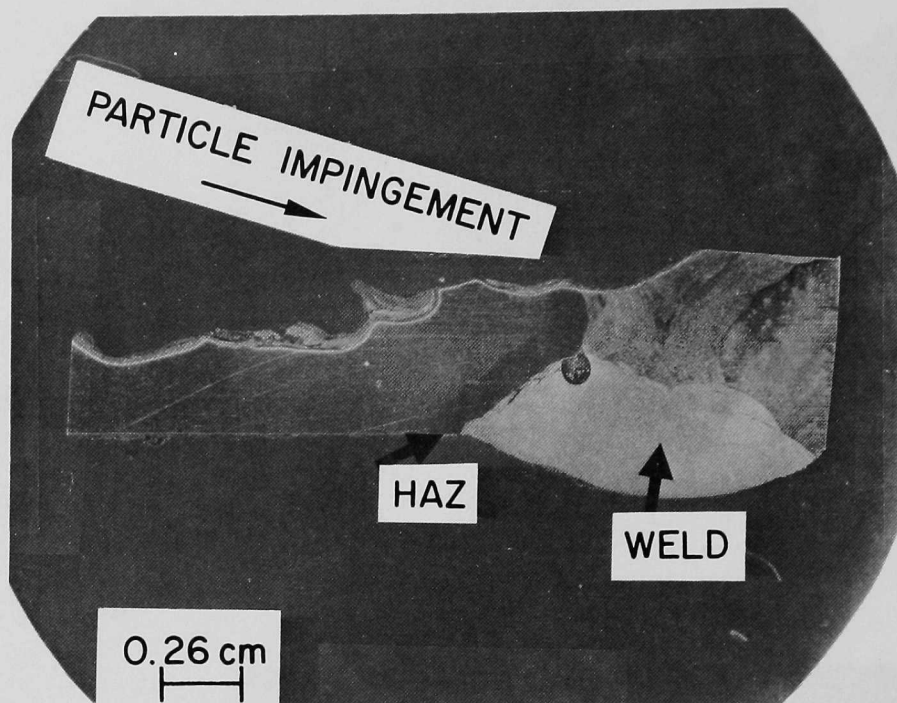
Fig. 65. Cross-sectional View of the Eroded Stainless Steel Insert in the Polished and Etched Condition. The heat-affected zone (HAZ) and the weld are readily seen. The surface topography reflects the incoming particle trajectories. Neg. No. ANL-306-78-570

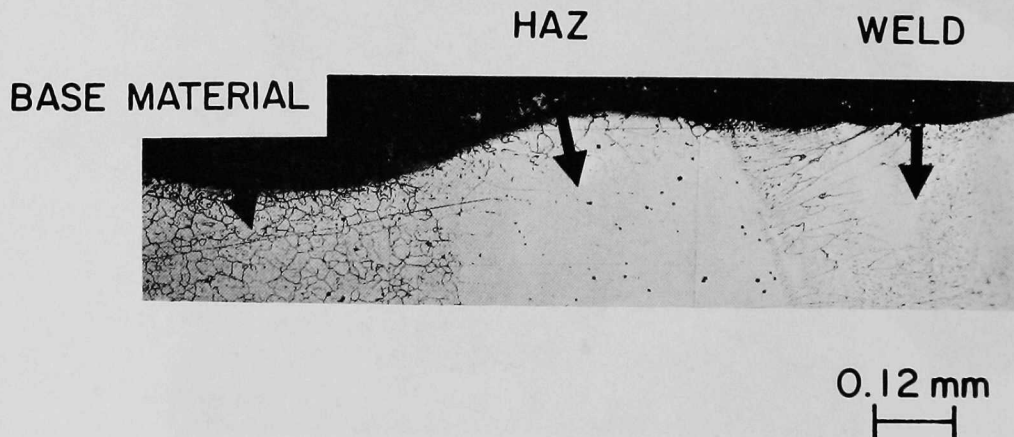
Fig. 66. The HAZ and Stainless Steel Insert at the ID. The HAZ has not eroded to the same extent as the insert material. Neg. No. ANL-306-78-591

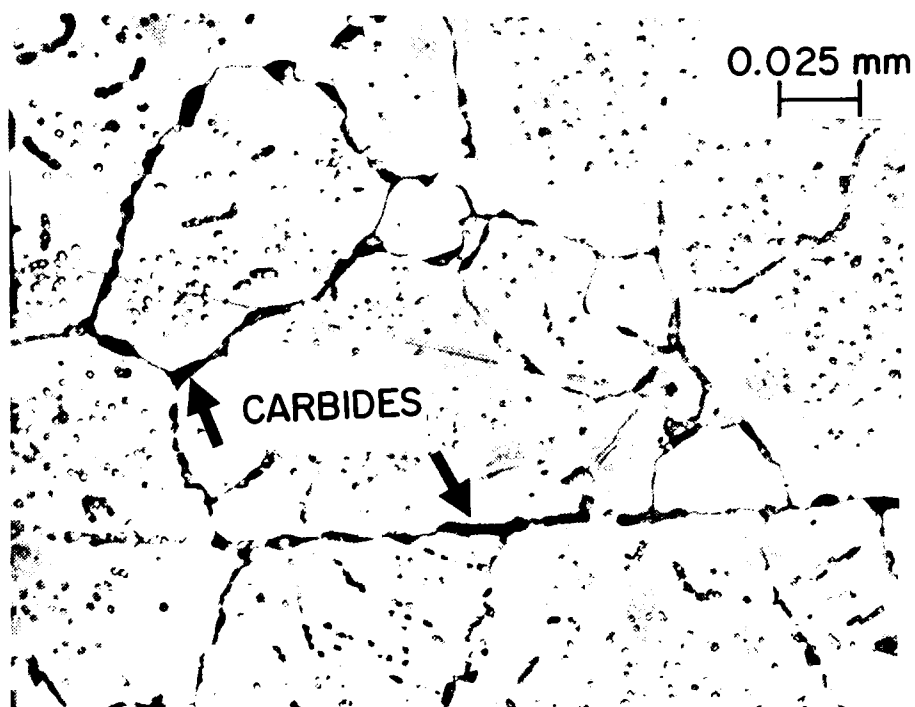
Fig. 67. Microstructure of the Stainless Steel Insert Material. Grain boundaries are decorated with carbides as a result of sensitization.
Neg. No. ANL-306-78-590

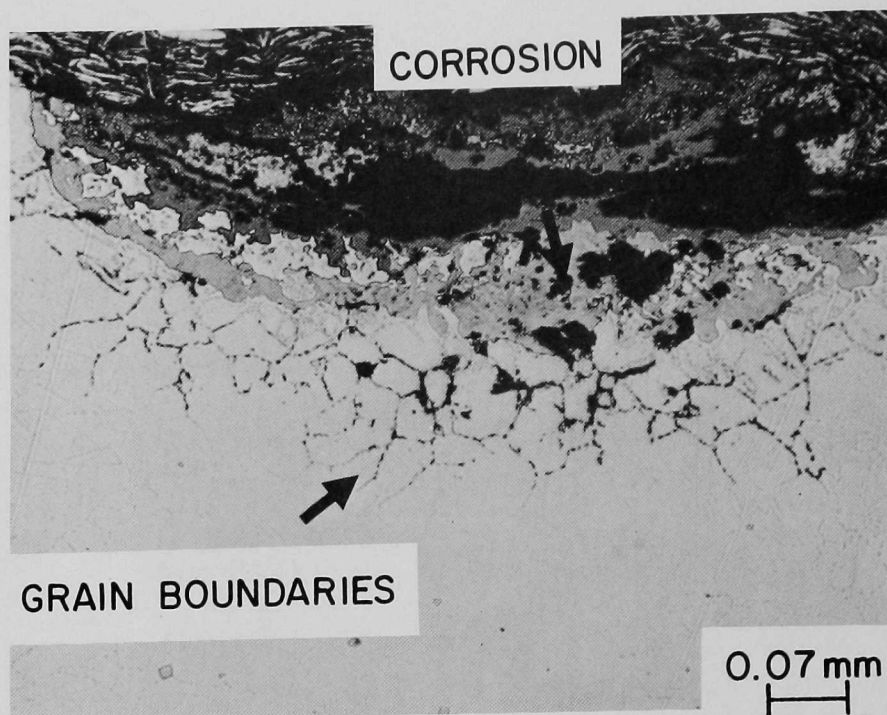
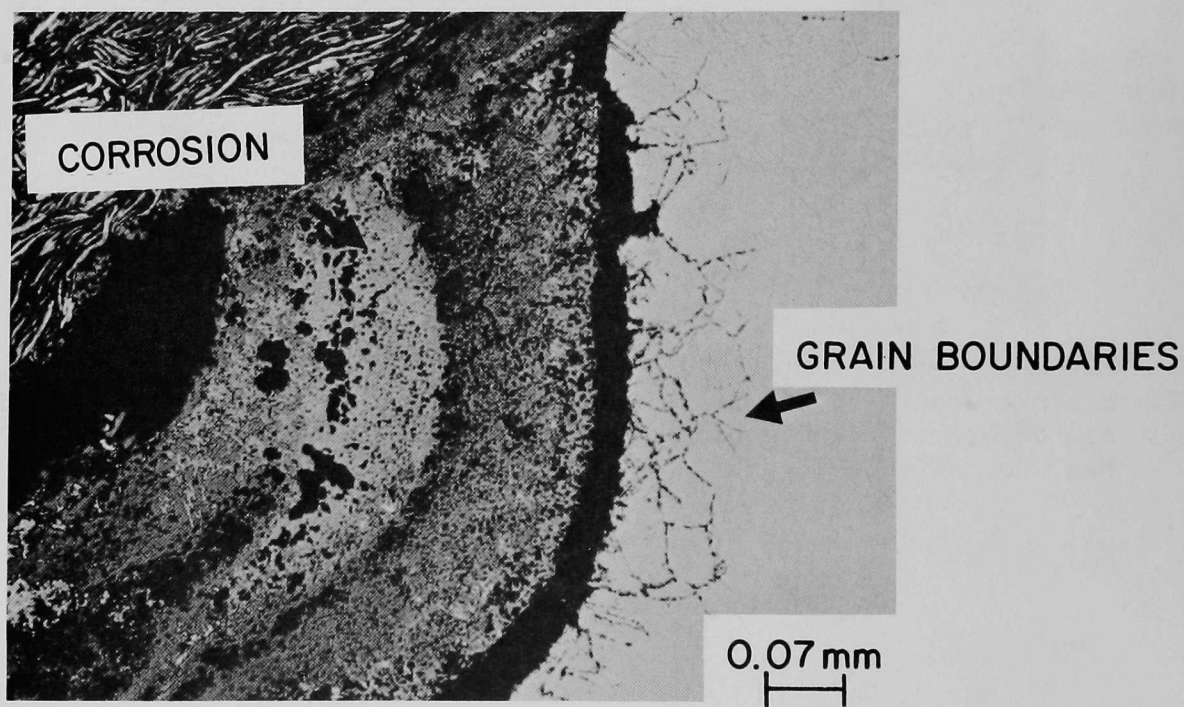
Fig. 68. Corrosion at the ID of the Stainless Steel Insert. The grain boundaries are embrittled, probably by sulfides. Neg. No. ANL-306-78-589
